Transformer Noise – Case Study

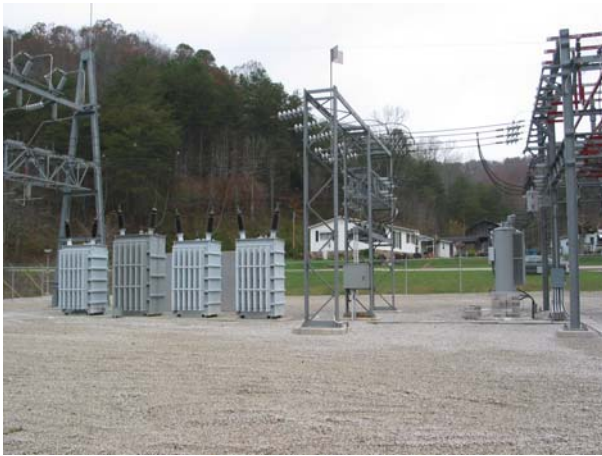
A power company contacted Unger Technologies regarding noise complaints from a residential area close to the company's transformer station. The customer attempted to erect a "plywood barrier" to help "stop" the noise. This was met with very little success.

Transformer station near residential house before

Unger Technologies was then hired to conduct a Sound Survey and Acoustic Feasibility Study. Unger performed this study in the field during different operating power loads. We conducted property line readings and compared those readings to any local noise ordinances. Our engineering conclusion and recommendation was for the erection of a modular acoustic steel sound barrier wall. Unger designed the height, width, and position to give the optimum sound reduction. Below is a picture of the transformer before the sound wall:

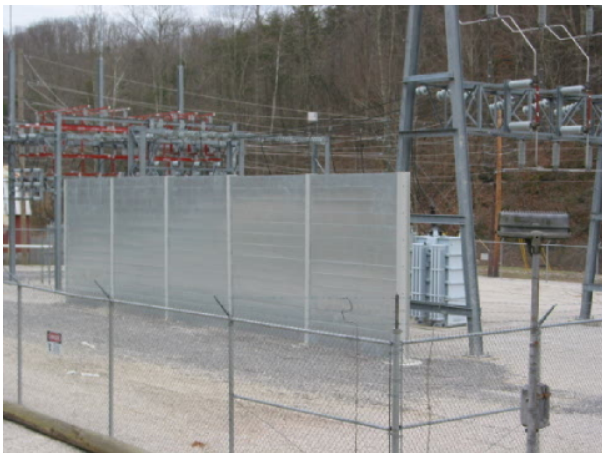
The next picture is a photograph of our recommended acoustic steel sound wall after installation.

Engineered sound control wall installed

Unger Technologies confirmed sound readings after installation of the acoustic steel sound wall that our acoustic goals had been met. Transformer noise can be low frequency tonal in nature and we do recommend hiring an Acoustic Engineer such as Unger Technologies to assist in the design of your noise abatement.
